Experiences with forest reclamation of settling basins after industrial processing of manganese ore and pyritic shales

ABSTRACT: This article describes the problem of forest reclamation of settling basins after industrial processing of manganese ore and pyritic shale at the age of 20–30 years. Soil properties of anthropogenic soil (overlaid layers, deposited sediments), nutrition state of assimilation organs, vitality of aboveground organs of tree species were investigated by instant visual evaluation using recommended macromorphological criteria and architecture of the Scots pine (*Pinus sylvestris* L.) root system.

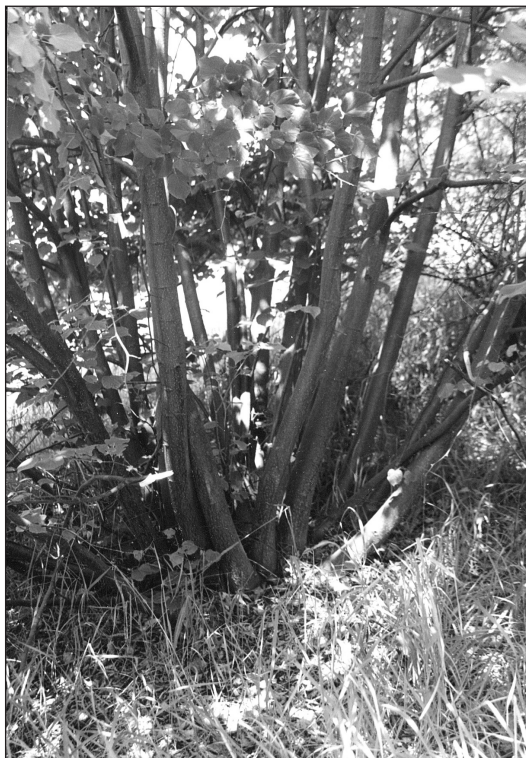
Fig. 1. Multiple trucks (*Tilia cordata* Mill.), frequent state of development also in *Betula verrucosa* Ehrh., *Acer pseudoplatanus* L., *Fraxinus excelsior* L., *Sorbus aucuparia* L.

- multiple trunks, development of multiple trunks in the tree taxa originally with one trunk (truncus) is marked by +;
 - proliferation (thickening) of the basic stem part between the inhibition growth of roots in the space of available rhizosphere and the aboveground part of tree species is marked as +.

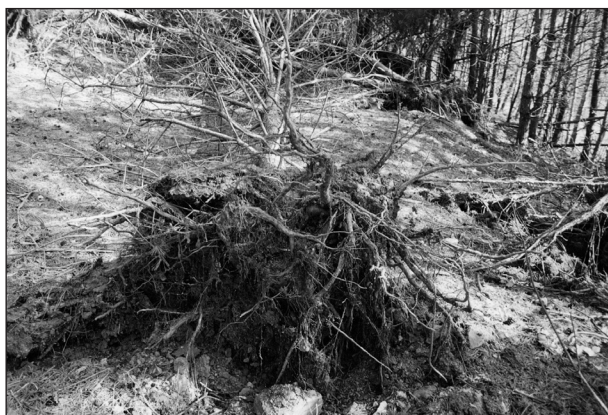
Fig. 2. The state of the root system of *Pinus sylvestris* L. in the slope part of dump (taproot – twin root is not developed)

The architecture of the formed root system was assessed mainly in Scots pine individuals that are the most damaged by windfalls at present. 24 trees were evaluated while the main attention with regard to the windthrow position (total area of the denuded root system) was paid to the type of formation of skeletal roots that involve horizontal roots and vertical roots – taproot, heart-shaped roots and vertical and oblique anchor roots. The evaluation of the root system is completed by findings obtained by the horizontal exposure of horizontal roots in six trees not damaged by windthrows.

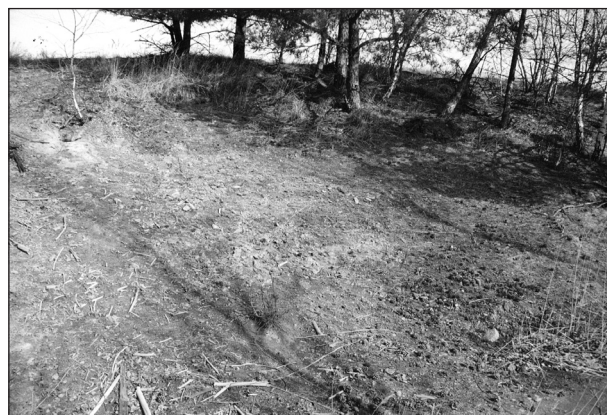
Fig. 5. The vegetation state characteristic of the dump surface damaged by water erosion with surface occurrence of deposited industrial waste

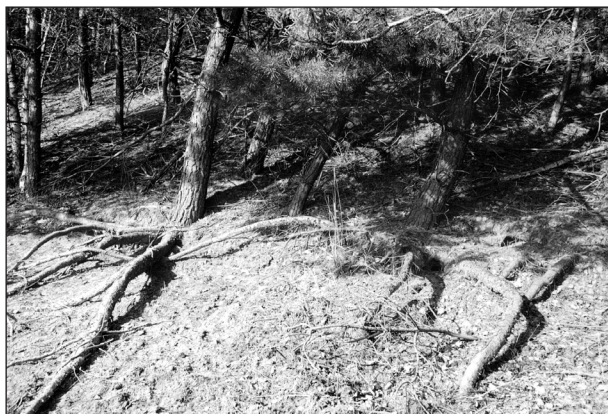
Fig. 3. The initial stage of *Pinus sylvestris* L. windfall (the static load of the set of horizontal roots is not in correlation with the developing aboveground part)
