## Causes and Consequences of a Flood Wave on the Lower Reach of the Dyje River Near Břeclav

**Abstract:** The settlements situated on broad flat floodplains of rivers are threatened by floods during increased water flows in the rivers. The floodplain of the Dyje river situated in the area between the Nové Mlýny water reservoir and Břeclav has been protected from former annual floods since the 70s of the last century due to the water-management measures. The realised measures including the construction of the new floodway protect the town of Břeclav as well. A long-term research into the soil water regime of the floodplain forest is underway in the region. The results obtained document its historical evolution and current status. Only in the early April of 2006 (i.e. after 34 years), an unexpected “flash flood” occurred again due to a specific climatic situation. The combination of the high snow cover in higher parts of the basin and a rapid warming up caused an intensive runoff. The so-called dry polder (floodplain forests, meadows and fields) above Břeclav protected the town and its infrastructure from potential catastrophic consequences.

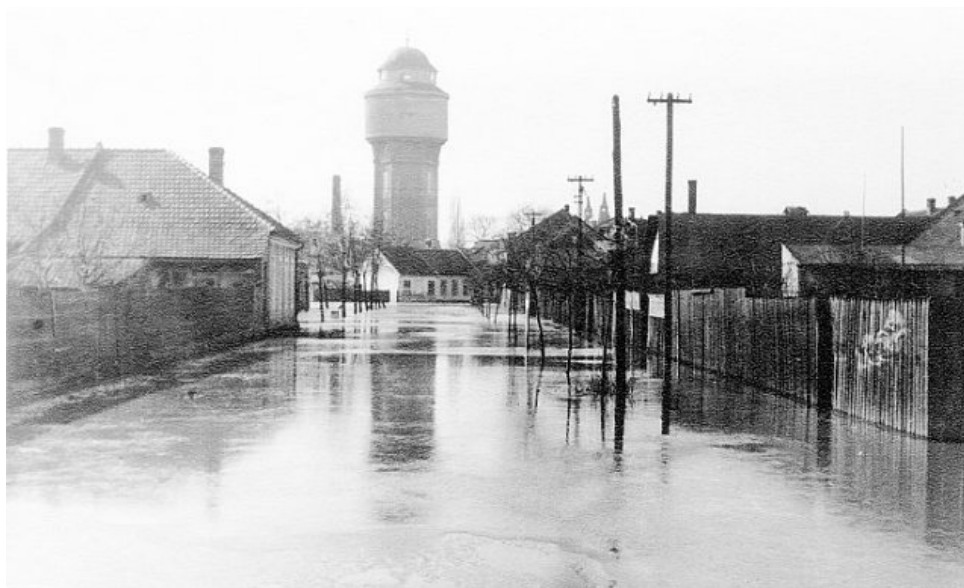
Figure 1. Břeclav – flood in 1941

example, spring floods in 1941 had catastrophic consequences (Figure 1).

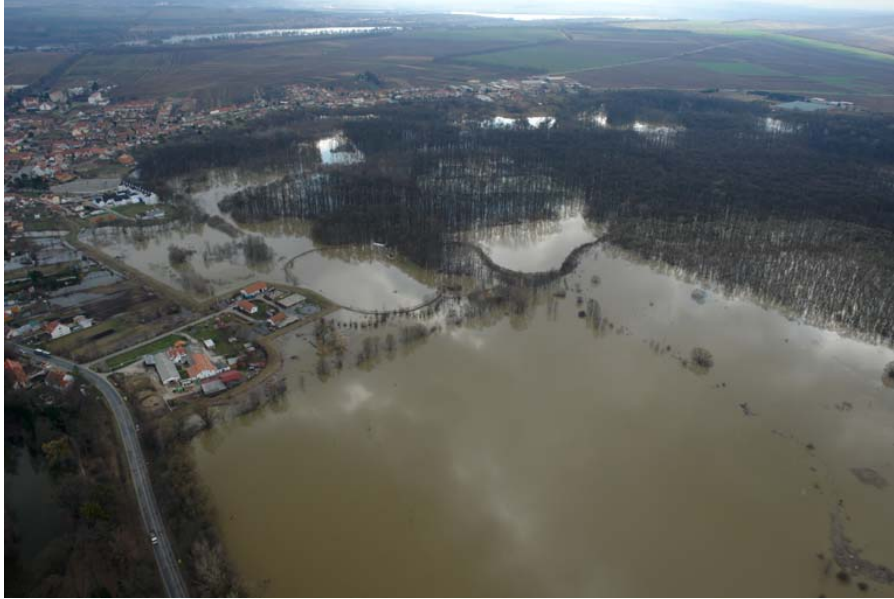
Figure 3. Flooded forest in the Horní les locality – Lednice na Moravě in late March and early April 2006 (photo by L. Rygl)

The floodplain of the Dyje river above the town of Břeclav (Figure 2) was affected by a large, several days lasting flood in late March and early April of 2006 (Figure 3) (HADAŠ & LITSCHMANN 2007). This situation shocked not only the water
