# Application of hard surfacing for repairing of agricultural parts

VIŇÁŠ J., BREZINOVÁ J., GUZANOVÁ A., KOTUS M., 2013. **Application of hard surfacing for repairing of agricultural parts.** Res. Agr. Eng., 59: 61–67.

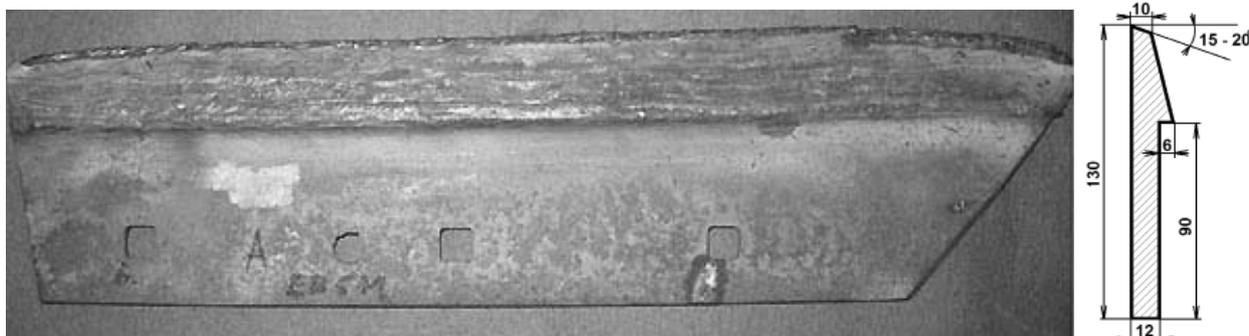
Fig. 1. Share with two-layer cladding produced with electrode E Z Fe 8 EN 14700 before machining on required dimensions

Next there was applied cladding on the cleaned and pre-treated share (see Fig. 1) by MMAW method with help of three types of additional materials: basic electrodes marked E Z Fe 8 EN 14700 (sample A), E Z Fe 15 EN 14700 (sample B). In the frame of so-called “technological innovation” (SPIŠÁKOVÁ 2008a), also experimentally-made basic electrodes EW11 (sample C) were included in the experiment besides the commercially used electrodes.

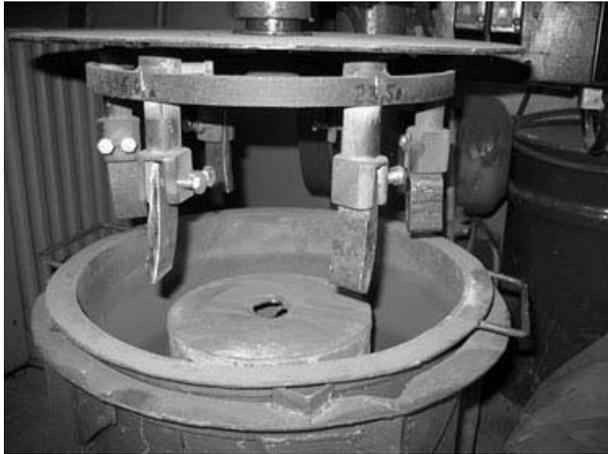
Fig. 2. Disk head with clamped samples

The test equipment is based on relative movement of samples in loose abrading agent. The disk head enables to clamp 6 test samples at once on the pitch diameter  $D = 270$  mm (Fig. 2). Slewing sam-

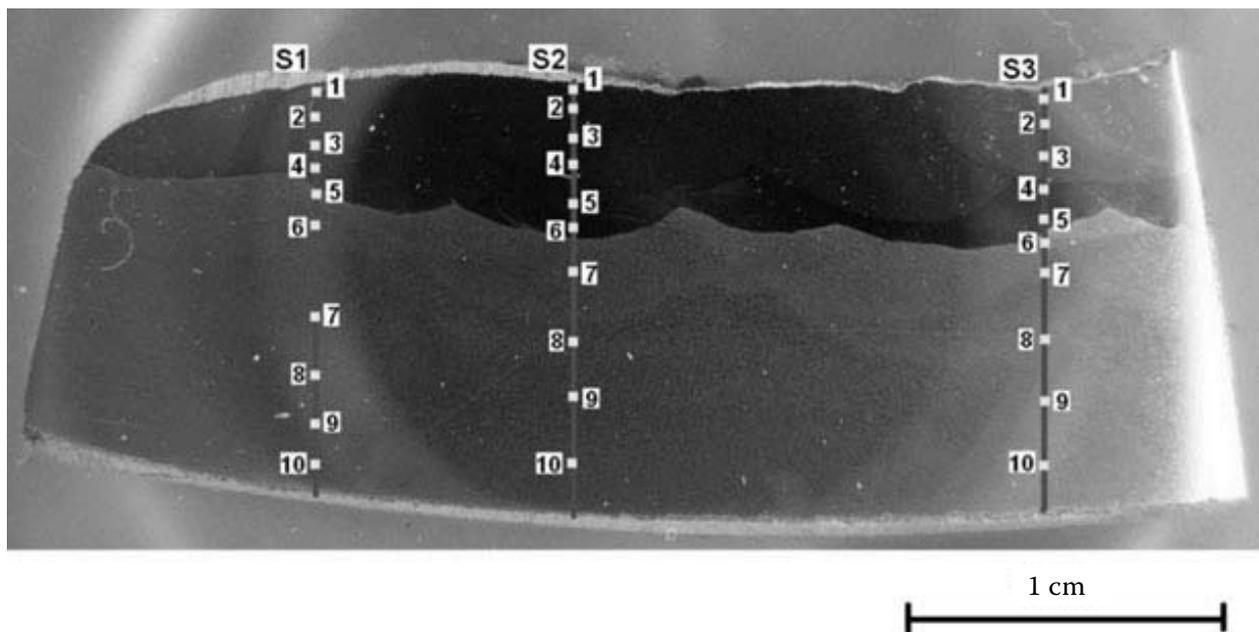
Fig. 3. Macrostructure of the share with two-layer cladding of C type with marked lines of micro hardness measurement

Micro hardness was measured on metallographic cross-sections (Fig. 3). On the three spots there were realised 10 measurements, which records hardness course from the thermally untouched base material up to the cover layer with respect to the standard requirement.

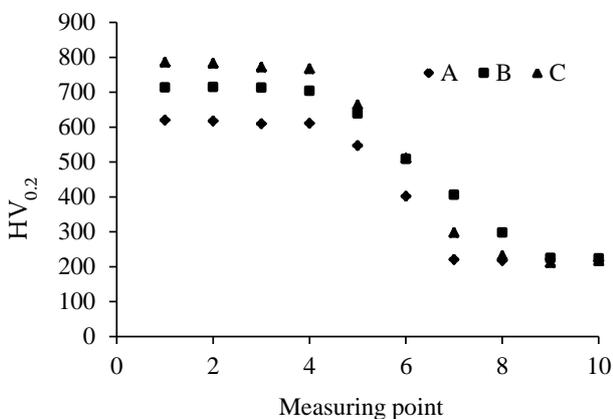
Fig. 4. Course of micro hardness HV<sub>0.2</sub> in two-layer claddings (electrodes A, B and C, Table 3)

Fig. 4 shows micro hardness course in the particular cladding layer up to thermally untouched base material. There was also observed shuffle of cladding layers with the base material. In one-layer cladding at observance of welding parameters didn't come to shuffle of cladding and base material in whole material volume, which was proved by micro hardness values in transition zone between base material – cladding. The highest hardness values were found out on the cover layer of claddings made out by electrode C – 798.3 HV<sub>0.2</sub>. Samples with cladding made out by the electrode A show maximum hardness value 632.8 HV<sub>0.2</sub> and the cladding made out by electrode B 726.3 HV<sub>0.2</sub>. All micro hardness values agree with values declared by producers of hard facing electrodes. Micro hardness corresponds to the chemical composition of claddings (influenced mainly by content of C, Cr, W, V) and the structure of claddings.

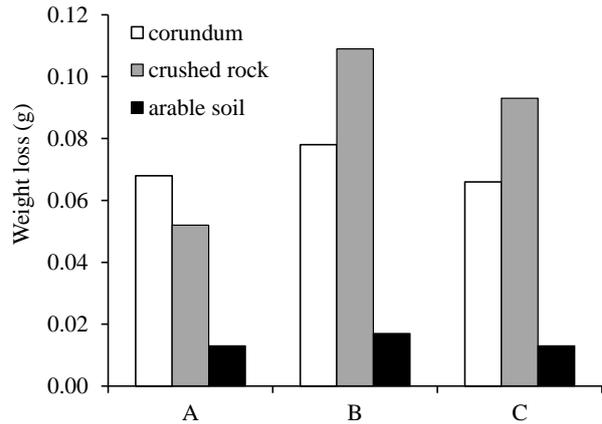
Fig. 5. Weight loss of one-layer claddings (electrodes A, B and C, Table 3)

The most intensive abrasive effect on evaluated materials showed corundum and crushed rock, which corresponds to the abrasive hardness. Least abrasive effect showed the arable soil. Weight loss of samples after wading in arable soil was multiple lower than weight loss of samples abraded by corundum or crushed rock.

Figs 5 and 6 show course of particular claddings wear expressed by weight loss.

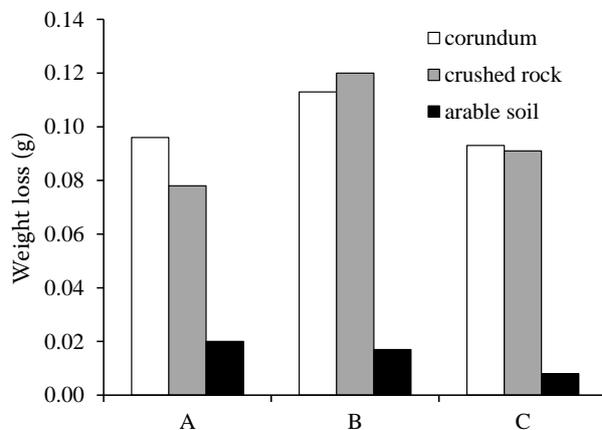
Fig. 6. Weight loss of two-layer claddings (electrodes A, B and C, Table 3)

The highest weight loss (0.12 g) was found in sample with two-layer cladding made by the electrode B after wearing in crushed rock. The least weight loss was found in samples with one-layer (0.066 g) and two-layer (0.093 g) cladding made by the electrode C after wear in corundum. Visual check of claddings surface after wearing showed due to the abrasive agent (corundum) removing of oxide layers and slag remained on the cladding surface. Samples after wading in crushed calcite rock was contaminated by the colloid calcite particles. The crushed rock as abrasive agent had not so negative effect on repaired surfaces as corundum, what corresponds to the weight loss values with the exception of two-layer cladding made by B electrode. Results of these experimental tests will be compared with results achieved by operating tests of repaired parts carried out in the agricultural cooperative Viničky, Slovakia.

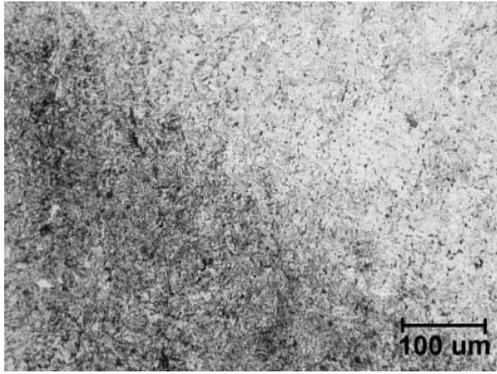
Fig. 7. Microstructure of HAZ C50R EN10083/1-98

Fig. 7 shows transition of HAZ (heat affected zone) into cladding layer made by the electrode A. The transition zone is close without marked shuffle with the base material.

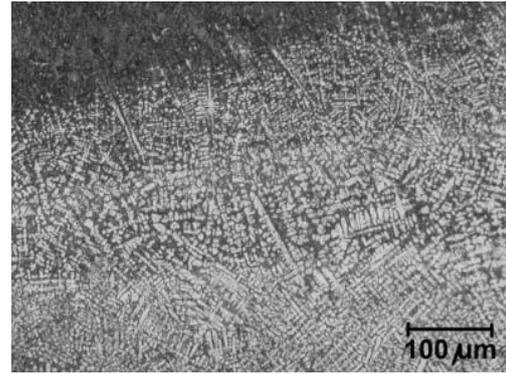
Fig. 11. Structure of austenite and eutecticum

of primary carbide particles in cladding (ATAMERT, BHADESHIA 1990). The cladding structure is shown in Figs 11 and 12.

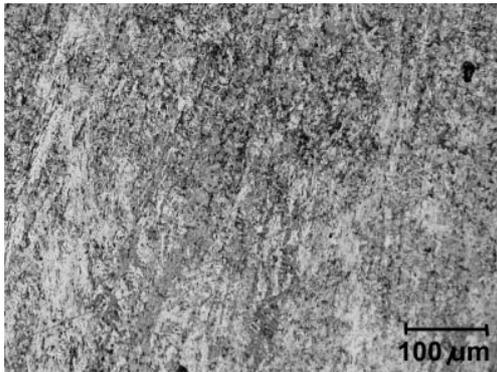
Fig. 8. Microstructure of the cladding sample A

Microstructure of the cover layer in Fig. 8 is martensite-ferrite. Structure mainly consists of the lath martensite and  $\alpha M_{23}C_6$  ( $Cr_{23}C_6$ ) carbides.

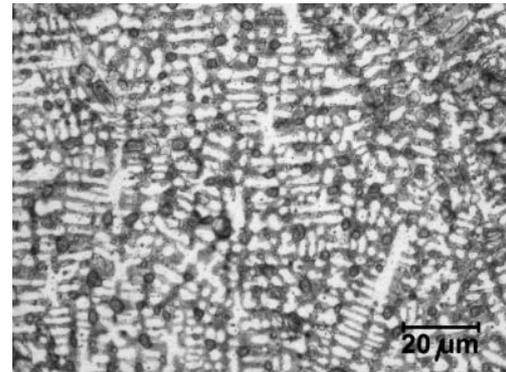
Fig. 12. Detail of eutecticum dendrites

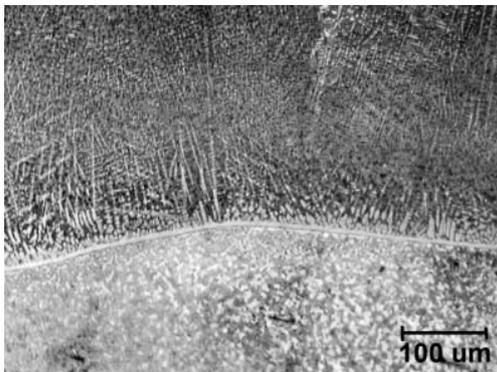
Fig. 9. Microstructure of the base material and cladding transition zone

Fig. 9 shows microstructure of HAZ and the cladding B transition zone. The transition between the base material and the cladding is relatively sharp without markedly shuffle of both metal. In HAZ expansion of pearlitic-sorbitic grains occurred in consequence of heat. Structure of the claddings consists of approximately austenite 35% and carbide eutecticum 65%.

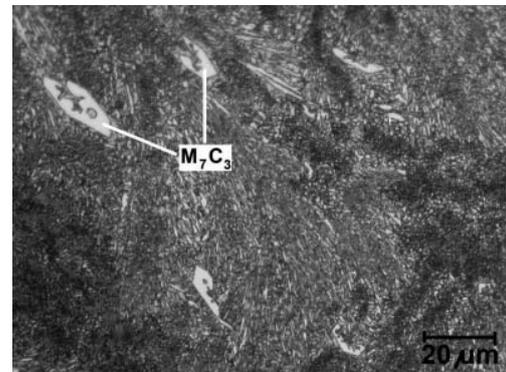
Fig. 13. Carbides precipitated in cladding layer made by electrode B

In the cover cladding metal (Fig. 13), dispersed primary carbides mainly of  $M_7C_3$  were used. Microstructure of the cover cladding metal made by the electrode C is shown in Fig. 14. The figure shows minimal shuffle of the cladding and base material. A lot of dispersed carbides  $MC$ ,  $M_7C_3$  were found in martensitic matrix of cladding. Considering high content of alloying elements W and V, the structure contains also less volume of  $WC$ ,  $VC$ ,  $V_4C_3$ ,  $V_6C_5$  carbides, which is proved by EDX (Energy Dispersive X-Ray) analysis and micro hardness values.

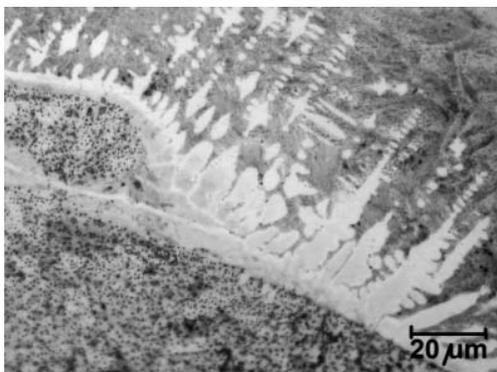
Fig. 10. Microstructure of HAZ and cladding transition zone

At the cladding microstructure in Fig. 10 it is possible to observe dendrite solidification with epitaxial growth of grains. Relatively high Si content (0.8%) decreases chromium content in austenite and thereby also corrosion resistance of the cladding and at the same time it influences dimensions

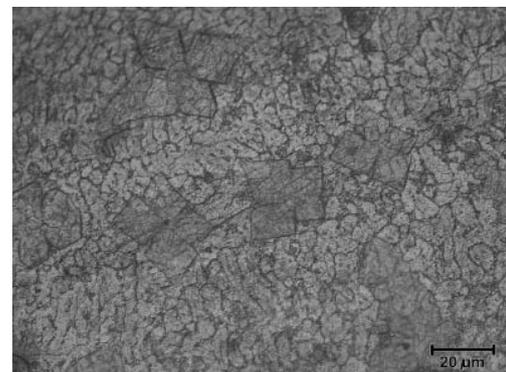
Fig. 14. Microstructure of the cladding layer made by electrode C
