## A car accident involving a restrained dog within the vehicle: a case report

**ABSTRACT:** The aim of this article is to describe and evaluate a unique car accident involving a pet dog within a car. The unique aspect is the linking and evaluation of information from the veterinary record with a detailed description of the car accident, the driver's injuries, the safety systems used and photographs. This method of complex evaluation of an injury mechanism is commonly used in forensic medicine when evaluating car accidents involving people. The accident is especially unique due to the fact that a dog safety harness was used to restrain the pet dog. The dog suffered severe injuries, whilst the car driver suffered only minor injuries. The conclusion was that the dog safety harness did not work correctly and did not protect the dog.

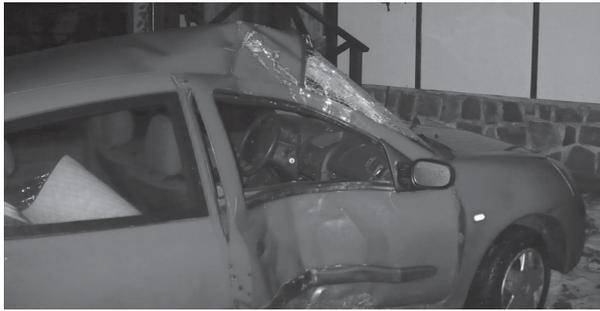
Figure 1. The vehicle after the accident

At the beginning of 2014, there was a car accident involving a young woman in the Czech Republic. The woman skidded in a curve on a snowy road at approximately 60 kph and hit a tree by the front passenger door. There was only her and her dog in the car. The driver was fastened by a seat belt, airbags were not activated, but the vehicle was damaged beyond repair (Figure 1).

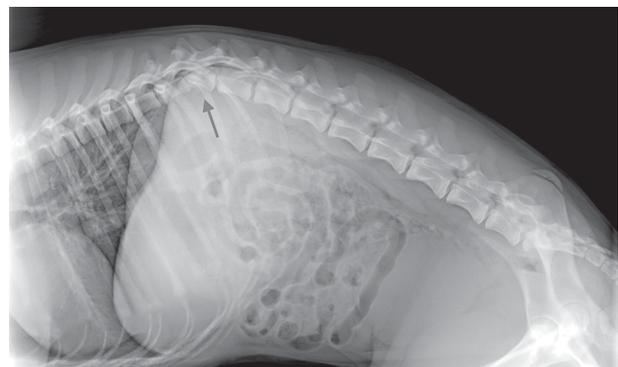
After the accident, the dog was treated in a Veterinary Emergency with lower limb paralysis; she did not urinate after the accident. There was a compressive fracture of the body of the 12<sup>th</sup> thoracic vertebra with spinal cord injury diagnosed from an X-ray examination (Figure 2). A pain medication was prescribed and euthanasia was suggested. The family decided to take the dog back home for a few days to allow the injured driver to say goodbye.

Figure 2. Lateral X-ray of the dog, compressive fracture of 12<sup>th</sup> thoracic vertebra is indicated by the arrow

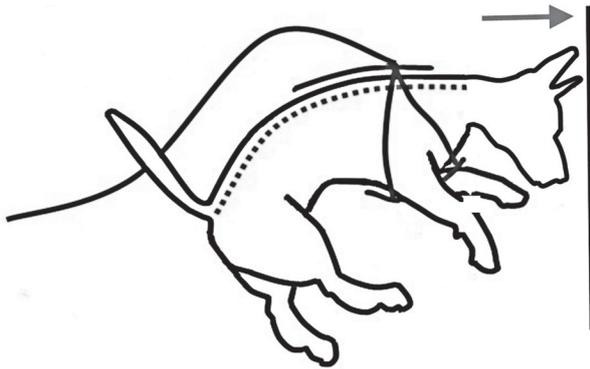
A compressive fracture of the body of the thoracic vertebra can be caused by two basic mechanisms. The first mechanism is a flexion and compression of the vertebral column along its longitudinal axis. This could be caused by the dog colliding with the interior structure of the car (Figure 3). In such a case, some external injury would be expected, mainly in the head area. No such injury was described in the veterinary record nor was visible in the pictures of the dog after the accident. However, this might not have been easily found considering the dog's thick hair, therefore, this injury mechanism cannot be excluded.

Figure 3. Dog colliding into the interior structure within the vehicle results in flexion and compression of the vertebral column along its longitudinal axis (by K. Grusova, J. Taus)

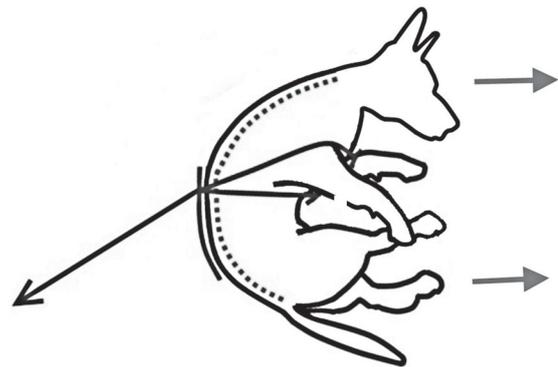
Figure 4. Rapid and intense traction on the back side of the harness at one spot resulting in the rapid and extreme flexion of the vertebral column (by K. Grusova, J. Taus)

The injury could have also been caused by the safety harness itself. The dog was fastened by the harness across its chest. This harness was similar to regular walking harnesses, but had wider and thicker front and rear straps. The belt was attached by a snap-hook to a single spot on the back of the harness, so that upon a collision the movement of the dog's body would be restricted by the belt's snap-hook. However, the head and lower part of the dog's body continued moving forward causing a rapid and extreme flexion of the vertebral column (Figure 4).

The authors would like to emphasise that the construction of a safety harness is crucial for dog safety. The ideal safety harness should be large and padded, unlike walking harnesses. Its dimensions should perfectly fit a particular dog's size and body profile, excluding the possibility of sliding onto the dog's neck and turning around the chest in case of an accident or sudden deceleration. The vertebral column has to be protected and the harness should have more than one point of attachment to distribute the impact load. The tether should be as short as possible. Even a non-fatal serious injury may still result in euthanasia; therefore, it is crucial to consider the quality of dog safety harnesses.
