Light and noise conditions of buildings for breeding dairy cows

ŠÍSTKOVÁ M., PETERKA A., PETERKA B., 2010. **Light and noise conditions of buildings for breeding dairy cows.** Res. Agr. Eng., 56: 92–98.

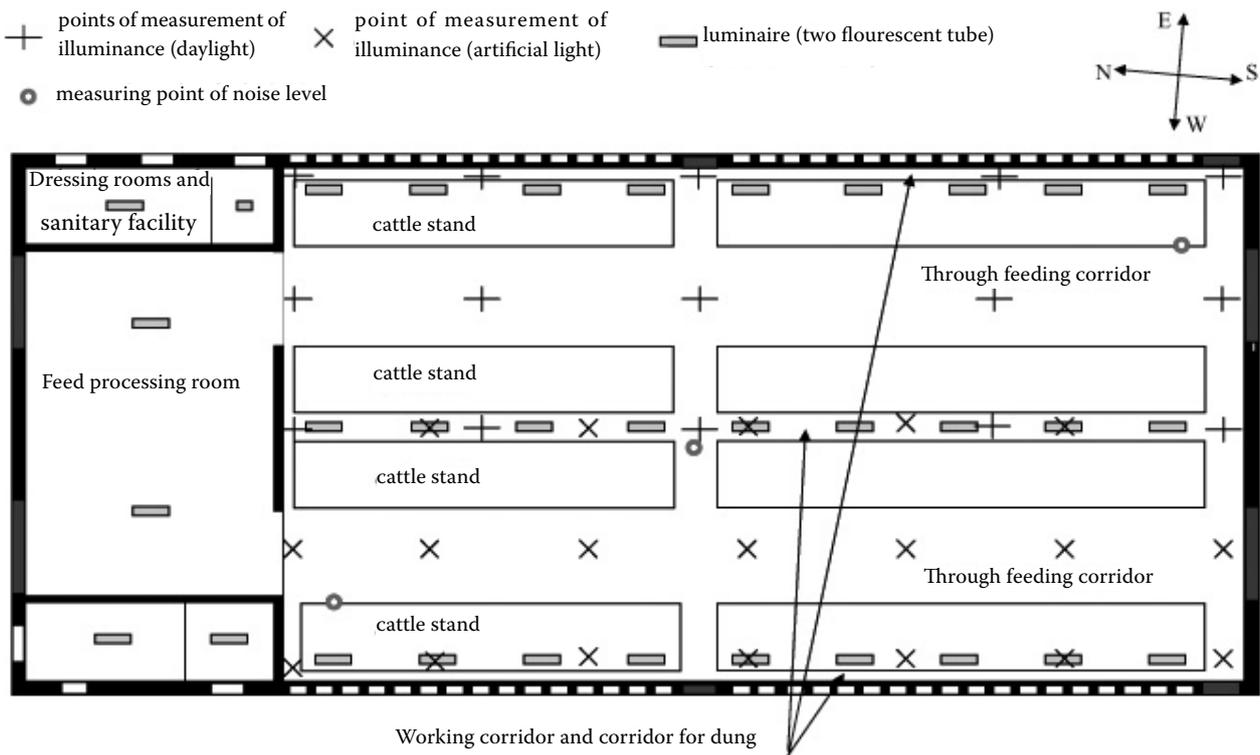
Fig. 1. Scheme of monitored object and points of measurement

As seen in the Fig. 1, the interior of the stable is symmetrical and the key lightning is located in a regular network with the same light source. Particular measuring check-points are not numbered because the measured values of light were almost the same at each point. At the time of testing the whole

The lighting is located over the three working corridors, 2.5 m over the floor in the side corridors and 3.7 m in the central corridor, Fig. 1. There are nine fluorescent luminaires with two narrow band tubes (diameter 26 mm) in each corridor. The supply of each tube is 36 W. The luminous flux is 3,450 lm and $R_a = 80$ (white fluor tubes). There are no light sources in the cross and feeding corridors. The daily illumination is ensured by simple windows along

the longer sides of the stable. There are side skylights in the east upper part. They serve for better illumination of the central corridors. The skylights have the same size as the windows (85×90 cm).

It took place in summer. The noise was measured at the measuring points (Fig. 1, height of microphone above the floor was 1.5 m) during these operations: milking, distribution of feed, distribution of litter, and during the removal of farm manure. The measurements of the background noise were carried out before each measurement (in our case, background noise is a noise of animals, so called biological noise).

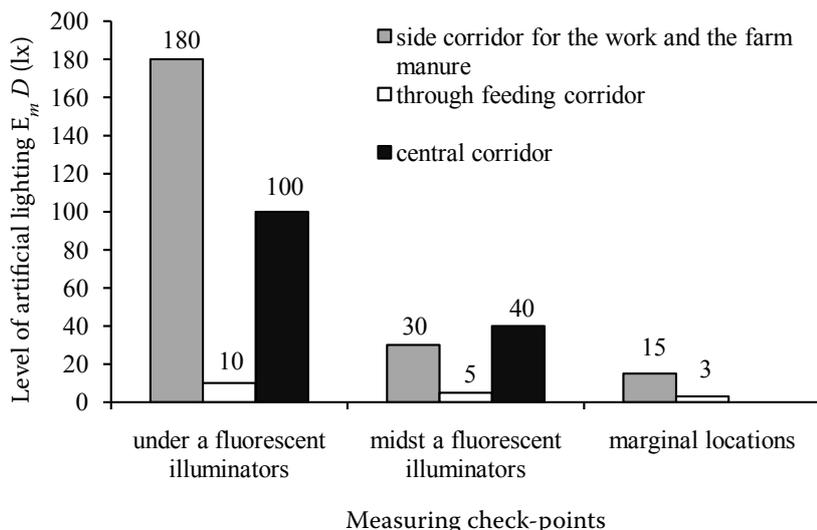
Fig. 2. Artificial lighting in particular points (corridors) of the monitored animal building

The level of artificial lighting (E_m) is different in each corridor, (Fig. 2). The level of artificial lighting (E_m) should be 200 lx. That value of E_m was only at the level of fluorescent tubes in the side corridors, but between the luminaires the value of E_m was only 30 lx. In the central corridors it was 100 lx under

the luminaires and less than 50 lx between them. The lowest values were measured at the edge check points. By far the smallest value of E_m was measured in the feeding corridors and central working corridor, where there are no luminaires $E_m = 10$ lx.

To improve the situation, the covering of the fluorescent luminaires should be cleaned. Another fluorescent luminaires with the same parameters should be installed in the edge parts of the corridors (gaps of 6 m). The intensity and uniformity of the lighting would be upgraded. In the central working and feeding corridors the current light source (Philips, 36 W, 3,450 lm) would be replaced by the light source with higher lm (Philips, 58 W, 5,400 lm). The height of location would be 3.7 m, to ensure good distribution of incident light. The lighting would probably rise

twice and the problem of low intensity of artificial lighting of feeding corridors would be partly solved. In each corridor there would be white tubes with good colour rendition ($R_a = 80$).

The number of luminaires would increase by ten in each corridor and the luminaires in the central corridor would be replaced. However, that would be financially more demanding.

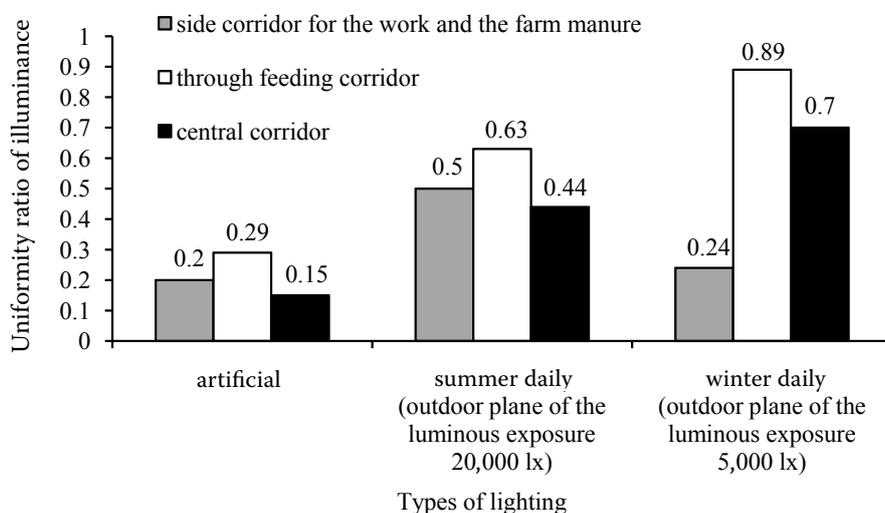
Fig. 3. Uniformity ratio of illuminance in particular points (corridors) of the monitored animal building

Fig. 3 shows total average daily and artificial illuminances in the particular points (corridor) of the monitored animal building K 174. Fig. 4 compares daylight factors D of the monitored animal building K 174 and factors of different styles of the stanchion housings (K 144, K 120, K 96) which ŠÍSTKOVÁ and PETERKA (2008) mention.

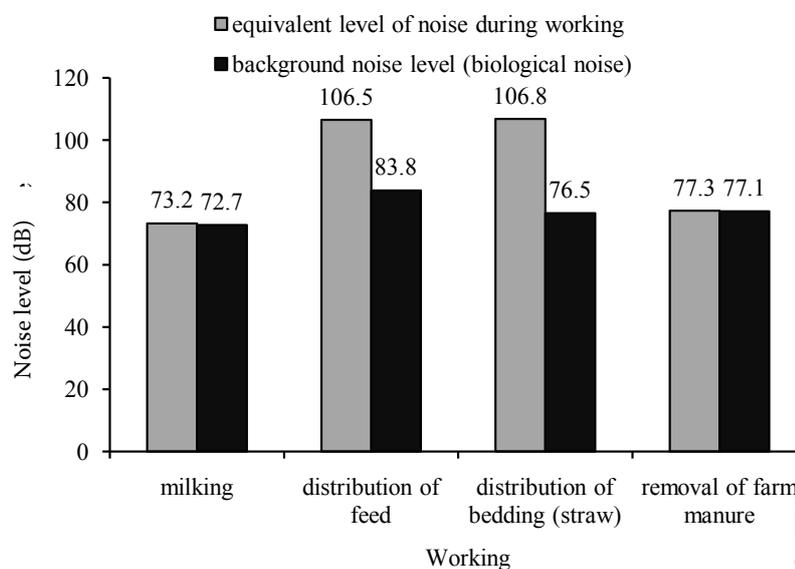
Fig. 5. Equivalent noise level during different operations in the monitored animal building

The mean values of the equivalent sound pressure level $L_{Aeq, 8h}$ were obtained in three measurements during following operations: milking, distribution of feed, distribution of litter, and the

removal of farm manure are shown in Fig. 5, for measuring conditions, Table 2.

The measured sound pressure levels for each working activity and the evaluation of the noise load; it can be claimed that the values of noise in the animal building are higher than the acceptable hygienic limit (distribution of feed and distribution of litter), but this noise takes effect for a short time (one passage of the tractor through the animal building lasts circa 3 min, 6 transits mean 18 min as a whole). The strongest noise was measured during the distribution of litter 106.8 dB (21.8 dB over the limit). The lower noise load than that allowed by

hygienic limits is the cause of other work activities such as milking and removal of farm manure.

The background noise level (biological noise) emerging from the biological manifestations of dairycows ranged from 72.7 to 83.8 dB (Fig. 5).
